Asbestos and Lead-Based Paint Survey Report

1690 Turnbull Avenue
Old Hosptial
North Charleston, South Carolina

February 20, 2019
Terracon Project No. EN197470

Re: Asbestos and Lead-Based Paint Survey Report
Old Hospital
North Charleston, South Carolina
Terracon Project No. EN197470

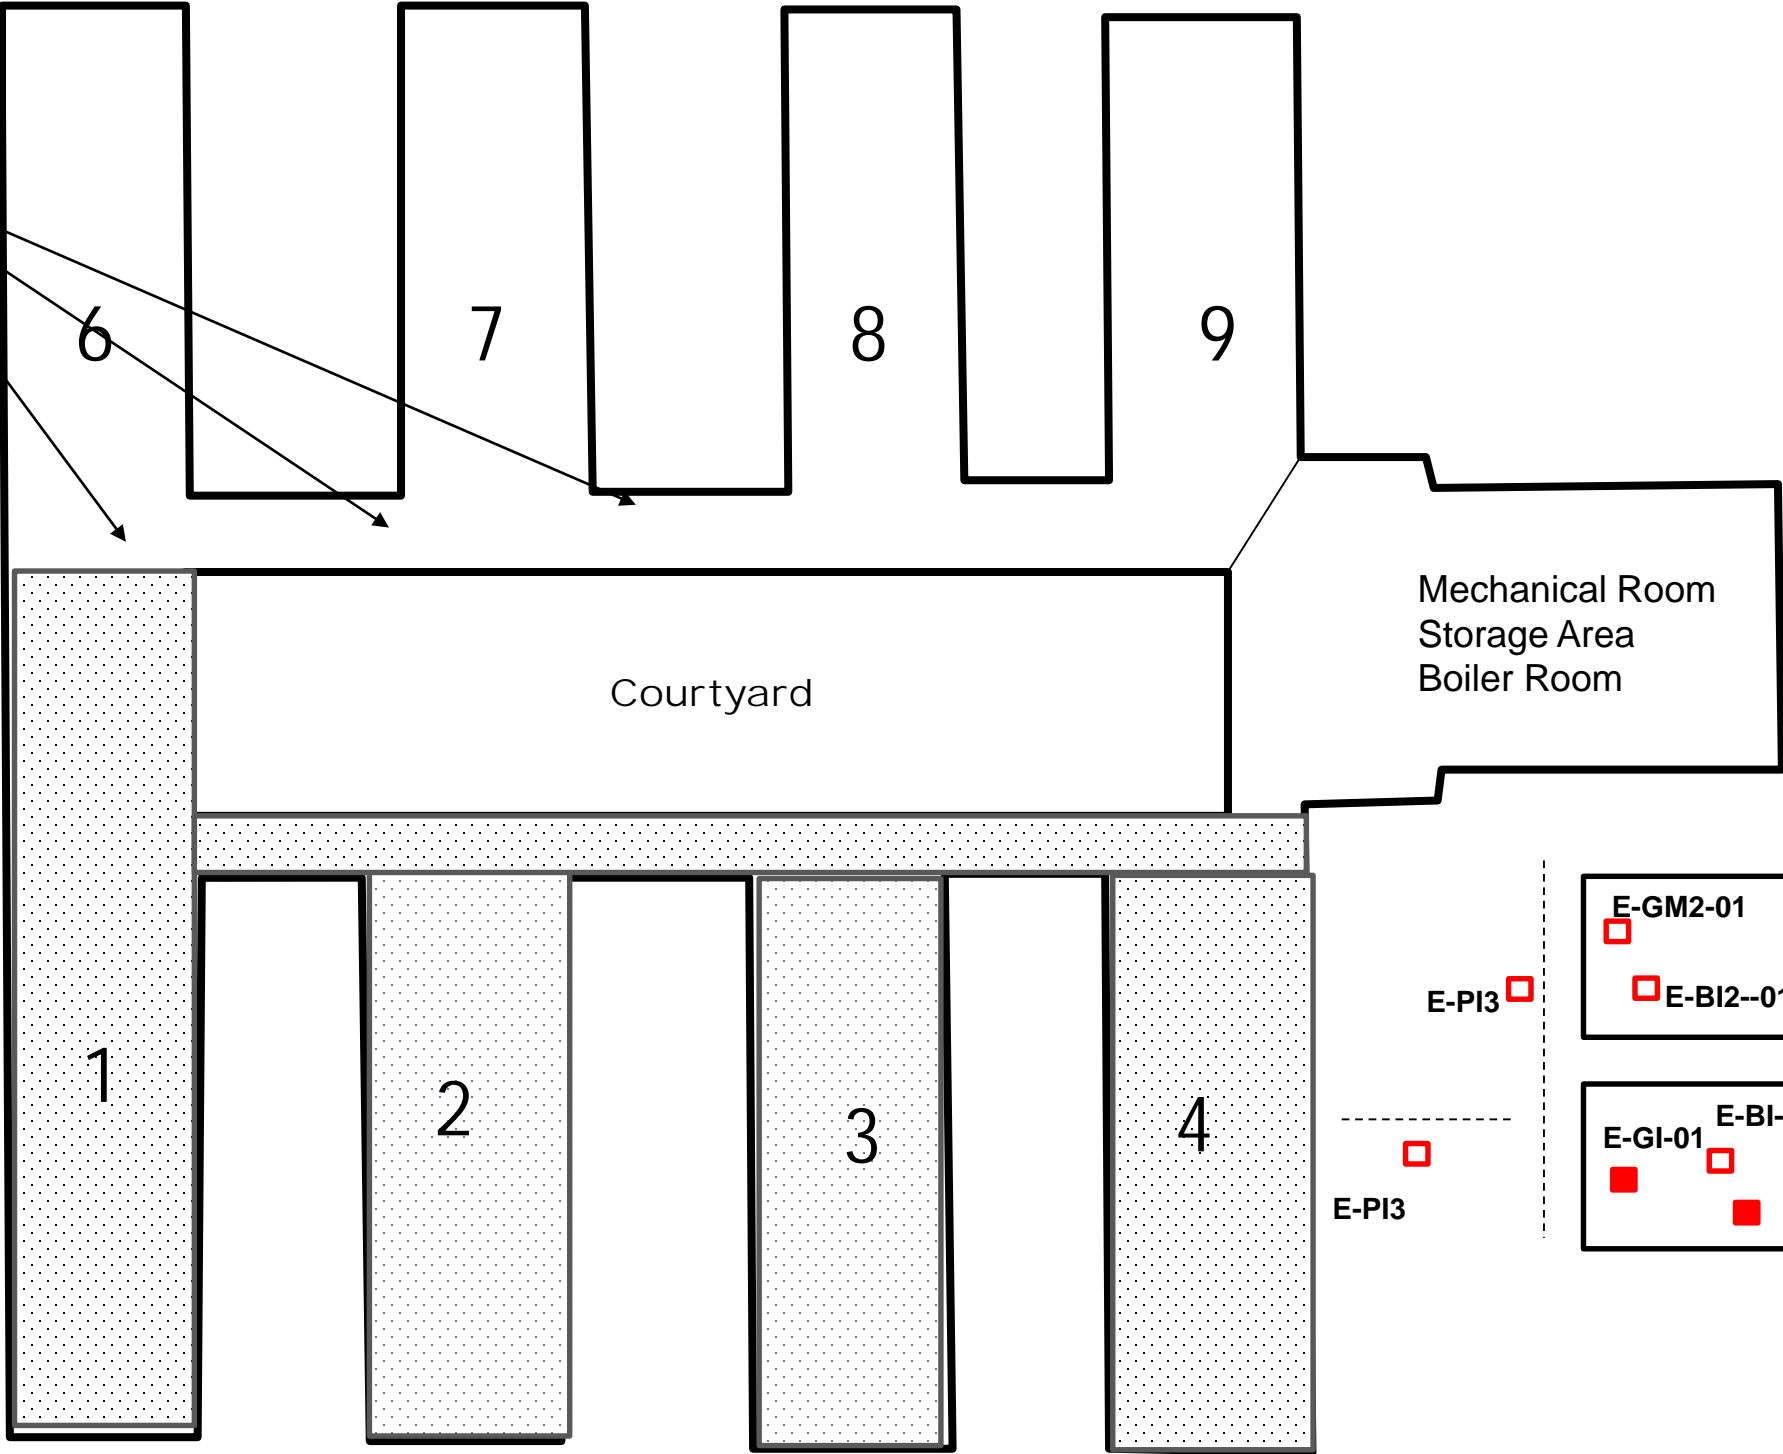
1st Floor

- Area Generally Unsafe to fully inspect.
- Partially under water
- Damaged building materials obstructing walkways from water damage

General area of contamination and damage observed during the inspection. Area is defined by visible observation only. The contaminated area may change due to the building being unoccupied and not fully secured. Others reviewing this area should make their own determination on the extents of contamination
